BUREAU OF RECLAMATION  
HYDRAULIC LABORATORY

HYDRAULIC MODEL STUDIES OF NAVAJO DAM  
SPILLWAY AND AUXILIARY OUTLET WORKS  
JUNCTION WITH THE SPILLWAY

Hydraulic Laboratory Report No. HYD-458

November 14, 1961

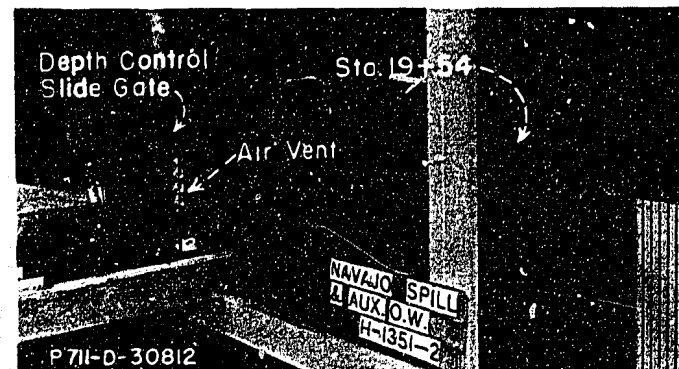
NAVAJO DAM SPILLWAY  
Model Views  
1:48 Scale Model

A. Crest section, bridge piers, and approach channel.

B. Auxiliary outlet works.

C. Spillway discharging 34,000 cfs.  
Note the water surface disturbance  
at right wall.

D. Stilling basin and discharge channel.

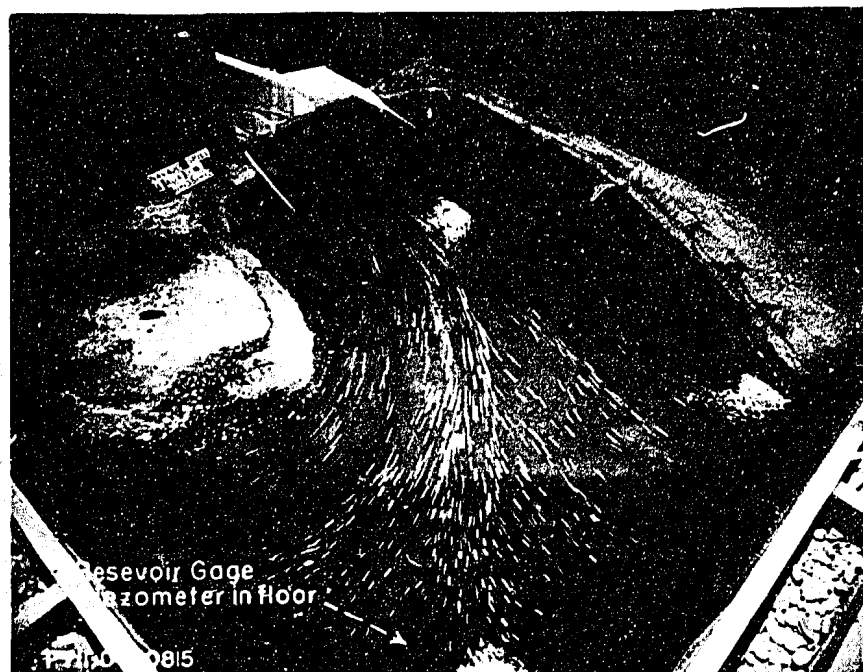
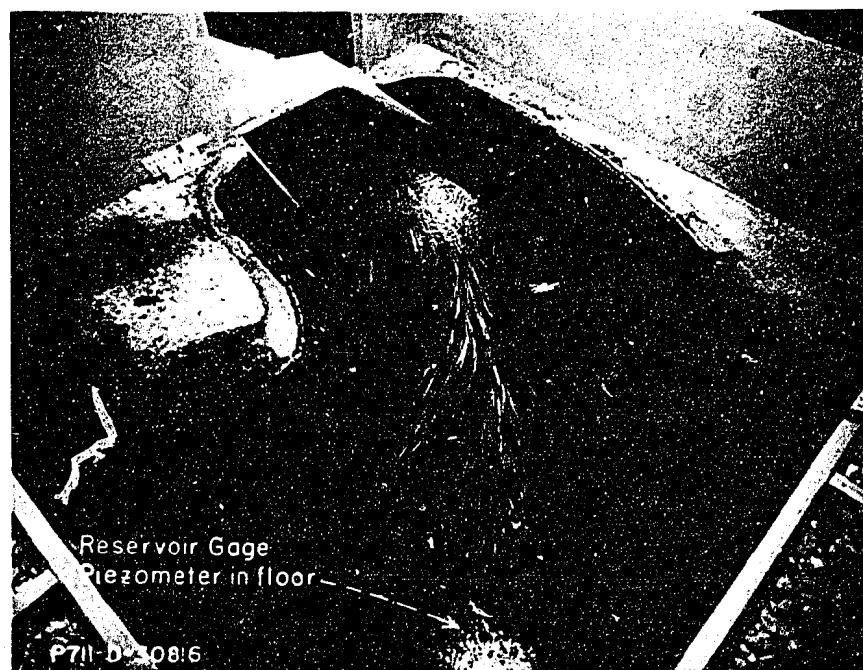
NAVAJO DAM SPILLWAY  
Flow in Preliminary Spillway Approach Channel  
1:48 Scale Model

A. 17,000 cfs, reservoir elevation 6095.5  
at gage surface velocity at head gage  
approximately 3-1/2 ft/sec.

B. 34,000 cfs, reservoir elevation 6101.2  
at gage surface velocity at head gage  
approximately 5-1/2 ft/sec.

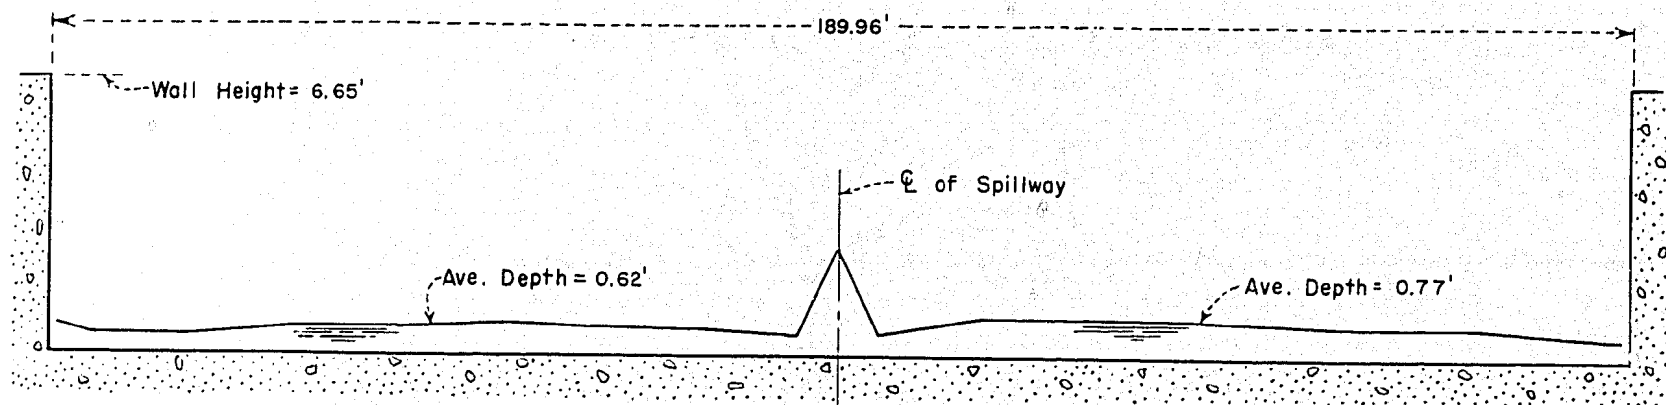
STATION 20+96 — LOOKING DOWNSTREAM  
AVERAGE VELOCITY = 64.89 FEET PER SECOND

Note: Depths measured  
normal to chute floor.

NAVAJO DAM SPILLWAY  
WATER SURFACE PROFILE IN THE CHUTE — 8,500 C.F.S.  
PRELIMINARY DESIGN

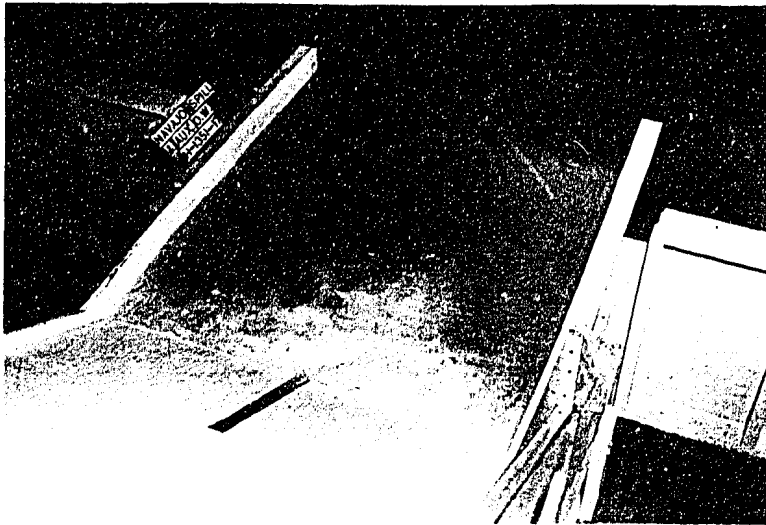
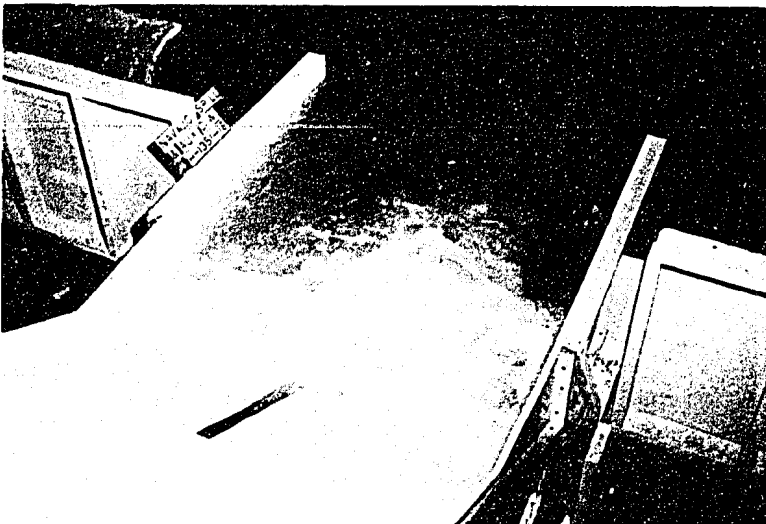
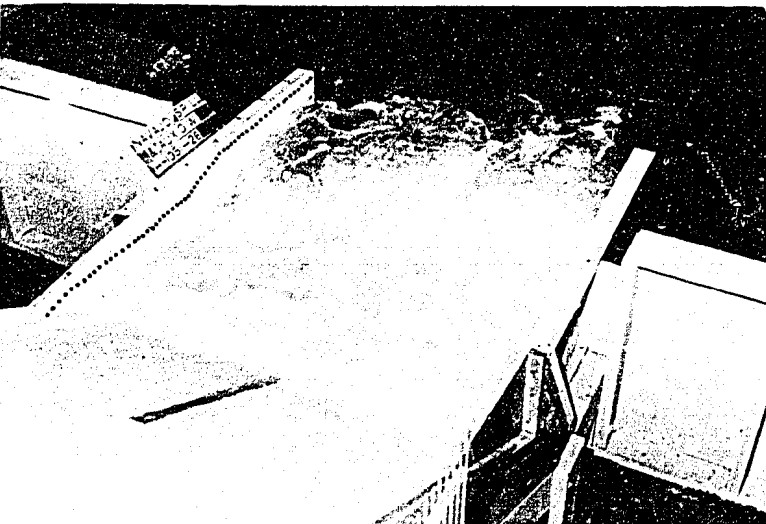
A. 8,500 cfs T.W.  
elevation 5713.

B. 17,000 cfs T.W.  
elevation 5714

C. 34,000 cfs T.W.  
elevation 5715.  
Dotted line is the  
water surface pro-  
file for T.W. ele-  
vation 5725.

NOTE: The uneven lateral distri-  
bution of flow entering the  
basin is indicated by the  
white water.

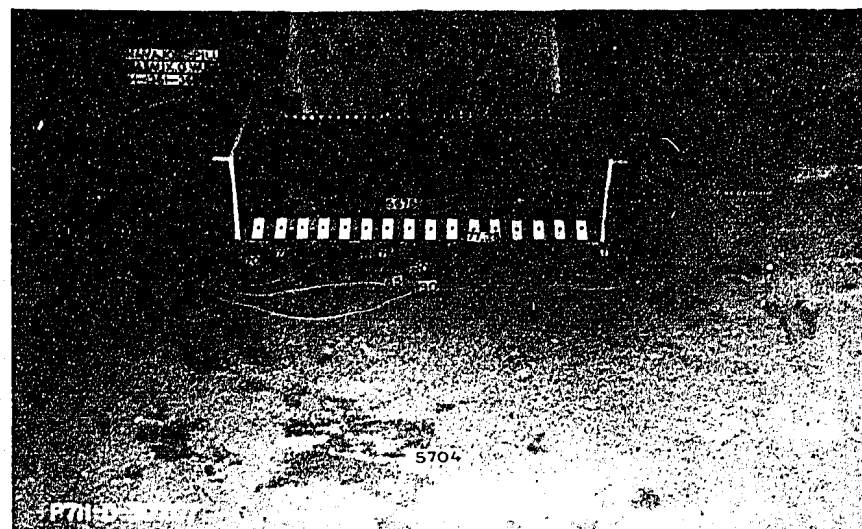
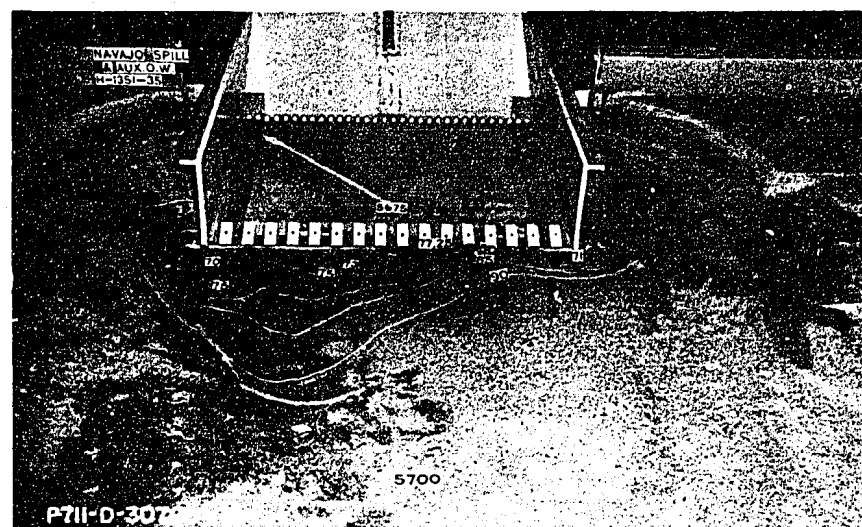
Tailwater elevation 5725.

Tailwater elevation 5715.

Erosion after 1 hour operation of the model.

NAVAJO DAM SPILLWAY  
Erosion For 34,000 cfs--Preliminary Chute and Stilling Basin  
1:48 Scale Model

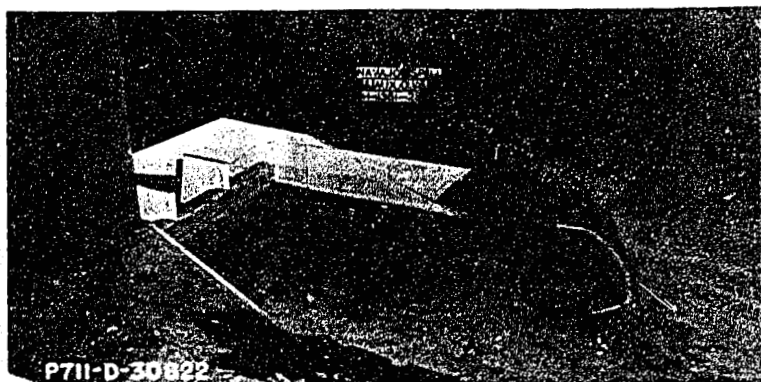
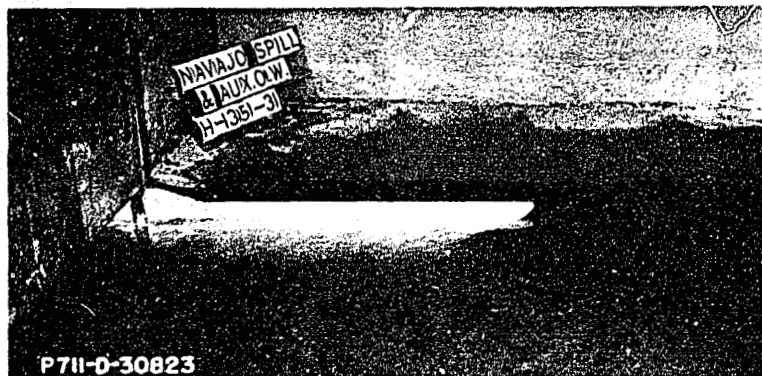
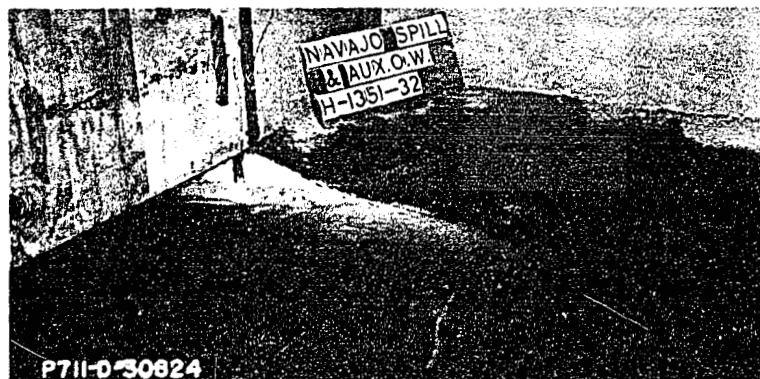
A. Improved right training wall.

B. Minimum disturbance at right wall with 34,000 cfs discharging.

C. Preliminary approach training wall 34,000 cfs discharging.

NAVAJO DAM SPILLWAY  
Flow at Right Training Wall  
1:48 Scale Model

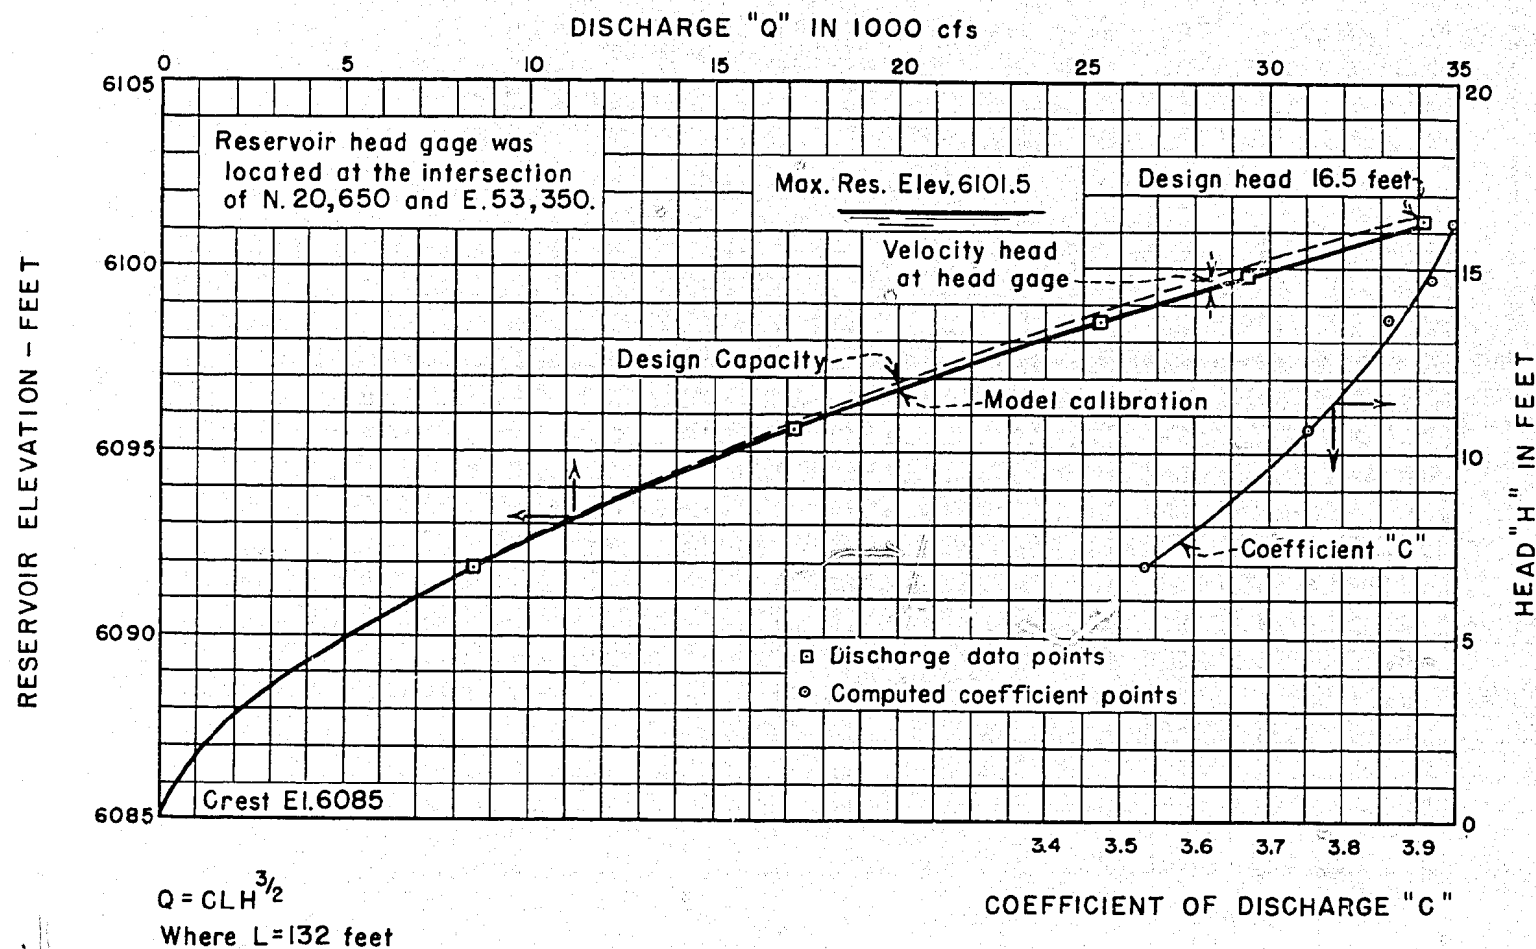
NAVAJO DAM SPILLWAY  
 SPILLWAY CAPACITY AND DISCHARGE COEFFICIENT CURVES  
 PRELIMINARY DESIGN  
 1: 48 SCALE MODEL

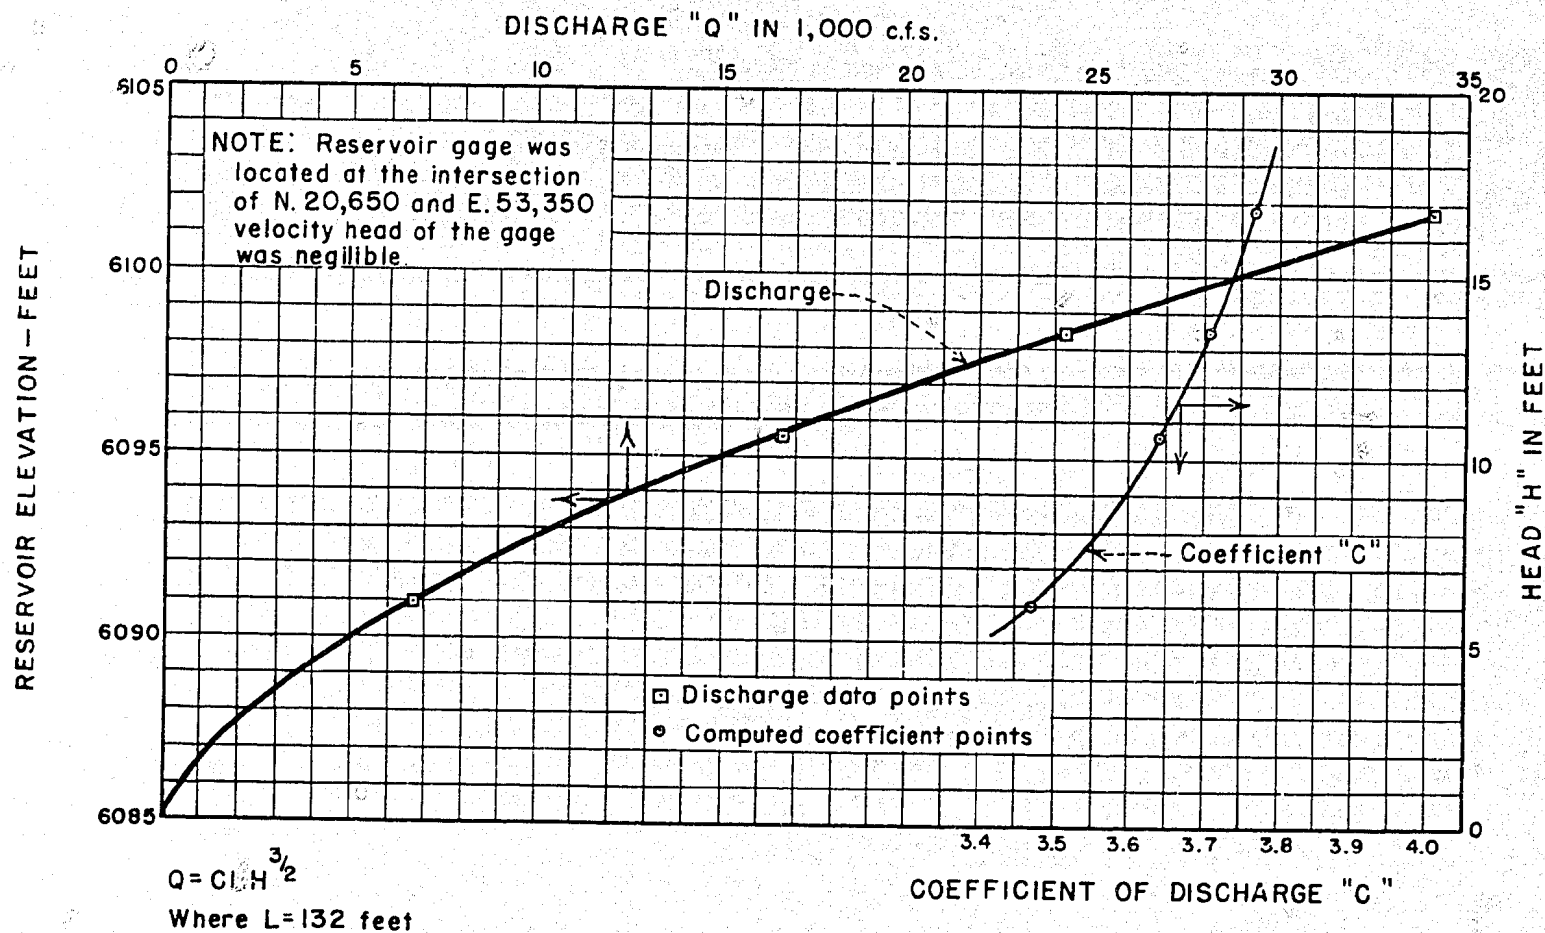
NAVAJO DAM SPILLWAY  
SPILLWAY CAPACITY AND DISCHARGE COEFFICIENT CURVES  
RECOMMENDED DESIGN  
1:48 SCALE MODEL

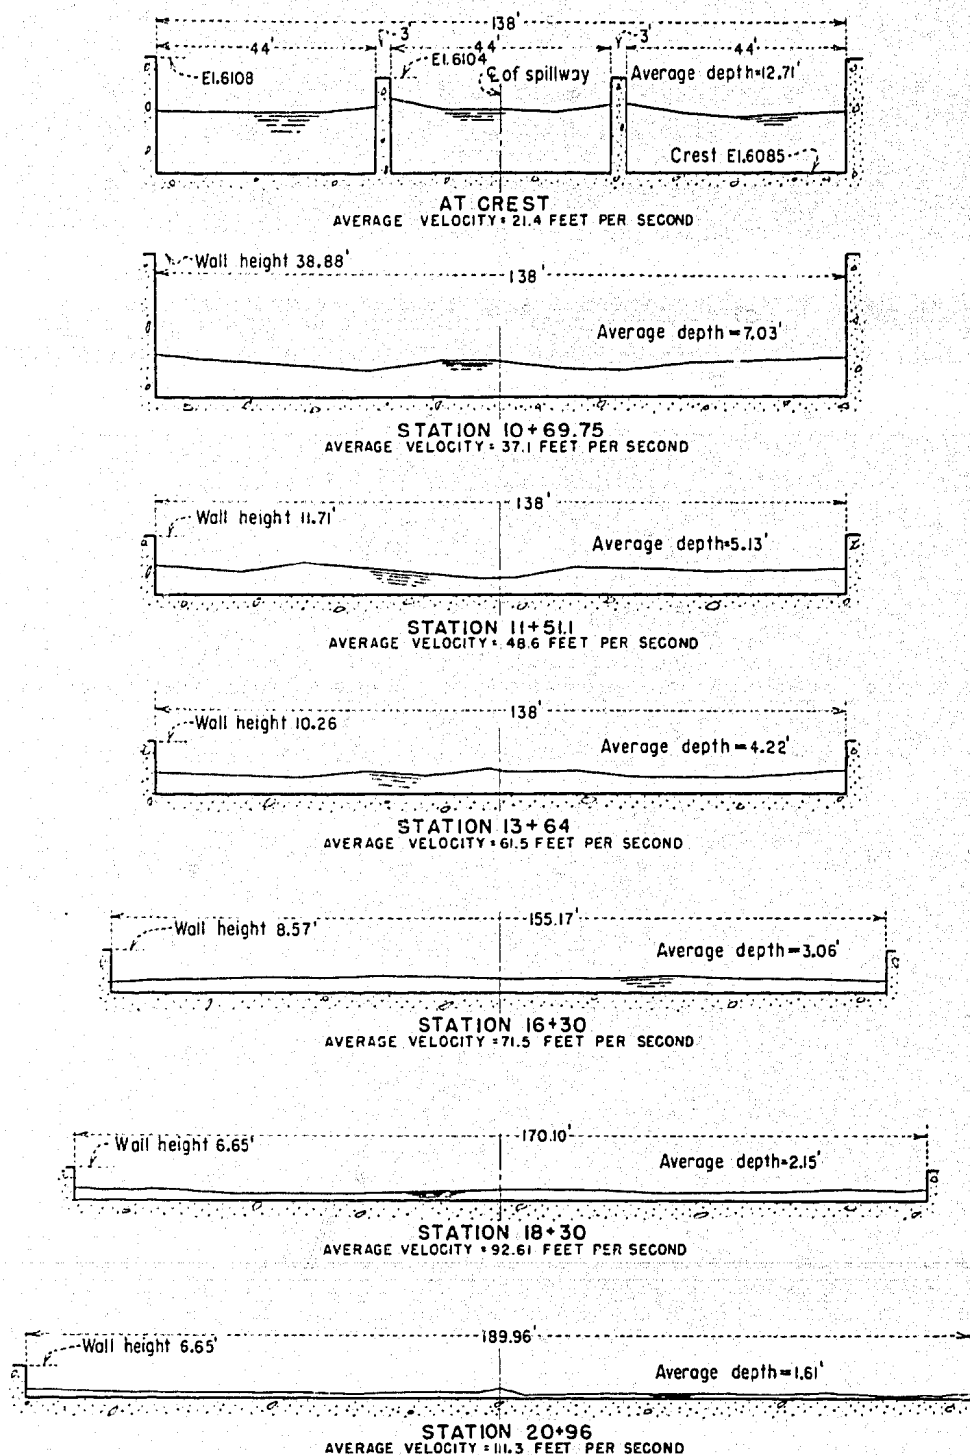
NOTE: Sections are shown looking downstream.  
Depths are normal to the chute floor. At sta.  
13+64 and continuing downstream the depths  
were measured by use of an electronic circuit.  
See figure 24 for plotted velocities.

NAVAJO DAM SPILLWAY  
WATER SURFACE PROFILES IN CHUTE-34,000 C.F.S.  
RECOMMENDED DESIGN  
1:48 SCALE MODEL

Water surface cross sections were measured and plotted at several stations along the spillway chute for the preliminary chute, and again later for the recommended chute (Figures 12 and 23 respectively). From these profiles the average velocity was computed at each station and plotted in Figure 24 for comparison with the velocities used in the design of the prototype structure and for verification of the estimated model roughness.

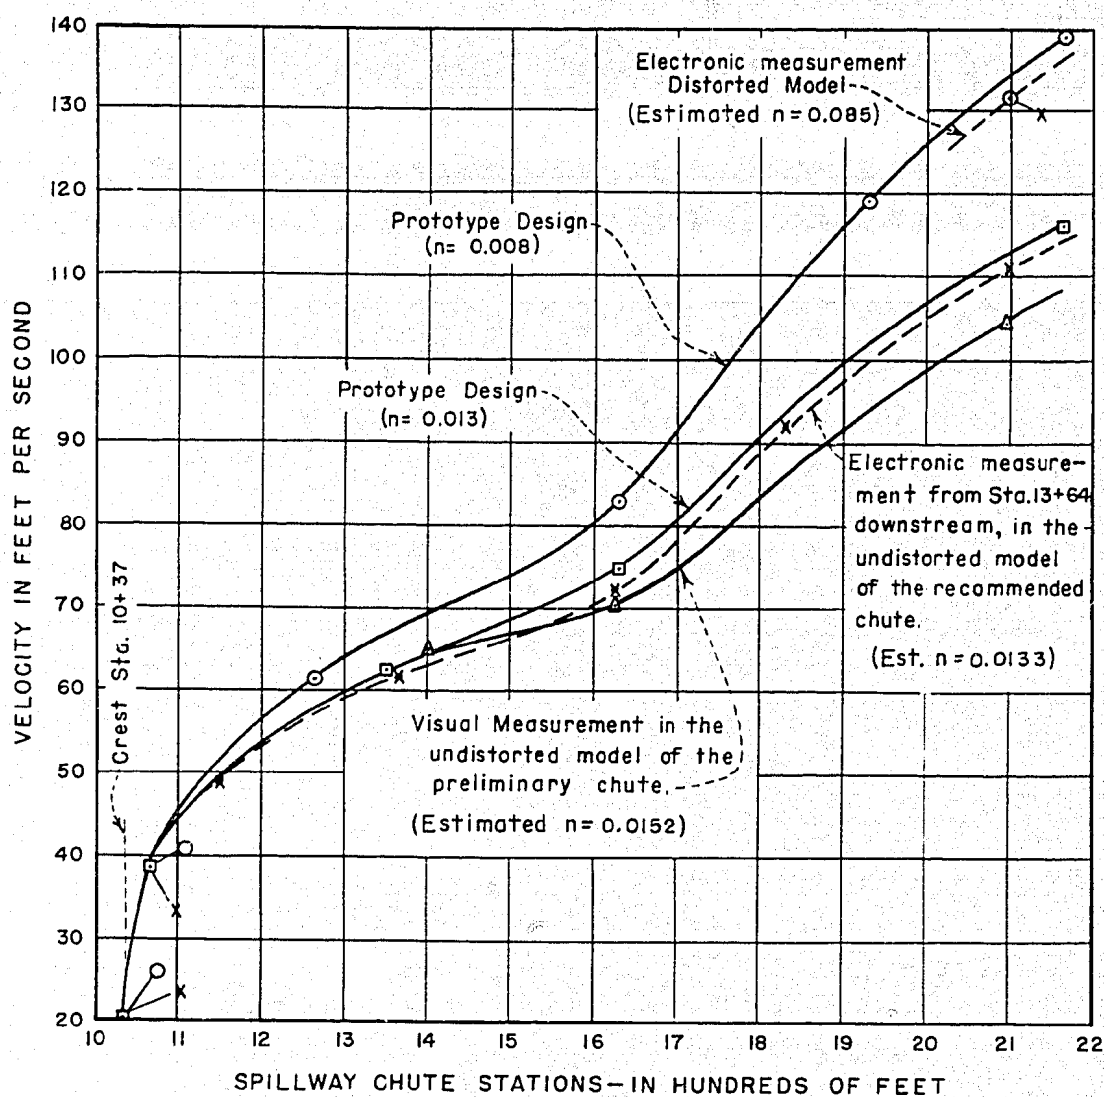
NAVAJO DAM SPILLWAY  
DESIGN VELOCITIES VS MEASURED VELOCITIES IN CHUTE  
34,000 C.F.S.

The average velocity for the maximum discharge at Station 20+96 computed from the electronic depth measurements recorded in Figure 30, was 131.5 feet per second for the design flow of 34,000 second feet, which when projected to Station 21+63.5 showed the entrance velocity to be about 135 feet per second (Figure 24). A roughness coefficient of about  $n = 0.0085$  in the computations would produce this velocity in the prototype.

Figure 14). In Figure 31 the entrance flow velocity as determined from the electronic depth measurements was 135 feet per second (Figure 24). In Figure 14 the entrance velocity as determined from the visual depth measurements was 110 feet per second (Figure 24). For the higher velocity the hydraulic jump extended farther beyond the end of the basin than for the lower velocity, and the toe of the jump formed approximately 10 feet farther down the slope of the chute (Figure 27) but the basin length was still adequate. The flow depths in the basin were very close to the same as for the lower entrance velocity. Chute block pressures were only slightly lower than those shown in Figure 28 for the lower entrance velocity in the undistorted model.

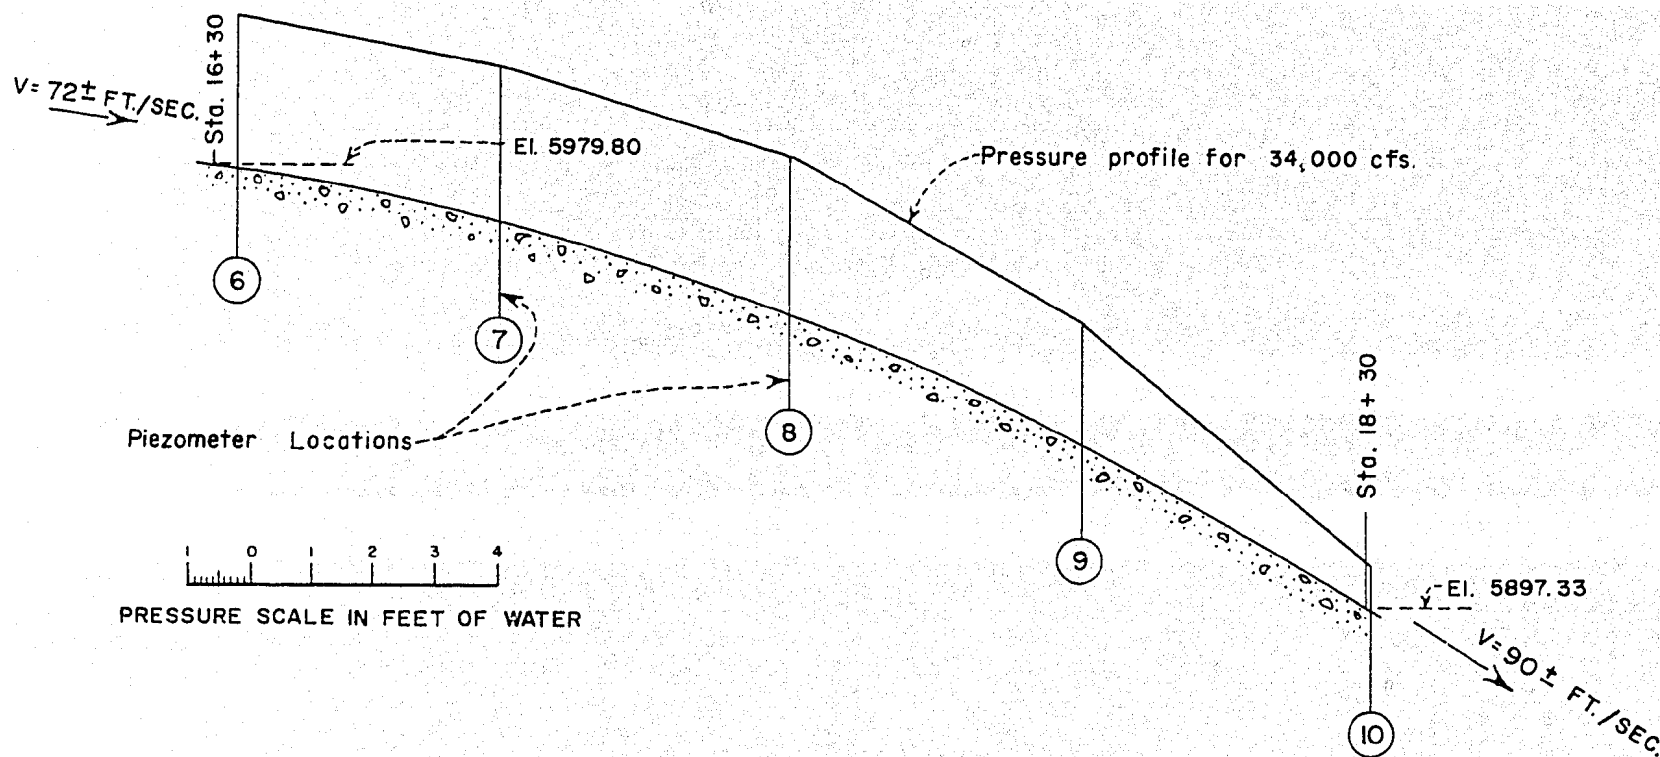
Pressures are above atmospheric and are plotted vertically upward using chute profile as the datum.

SECTION ON  $\phi$  OF SPILLWAY  
IN UNDISTORTED MODEL OF PRELIMINARY CHUTE

NAVAJO DAM SPILLWAY  
PRESSURES ON VERTICAL BEND IN CHUTE

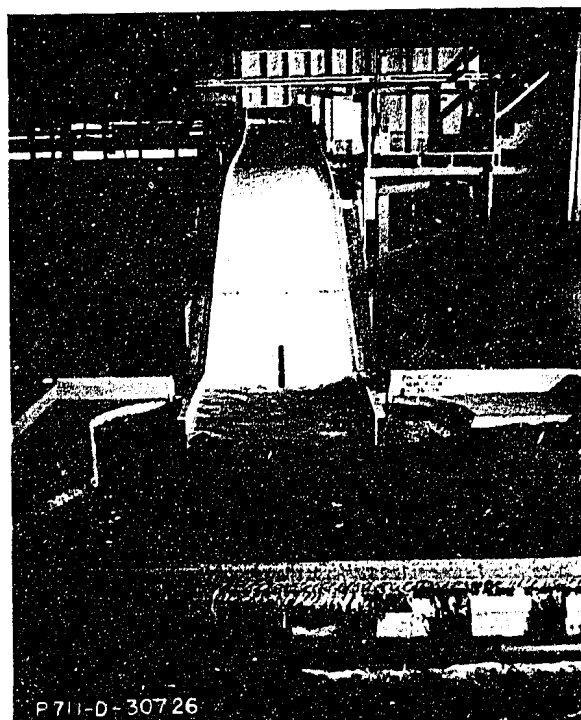
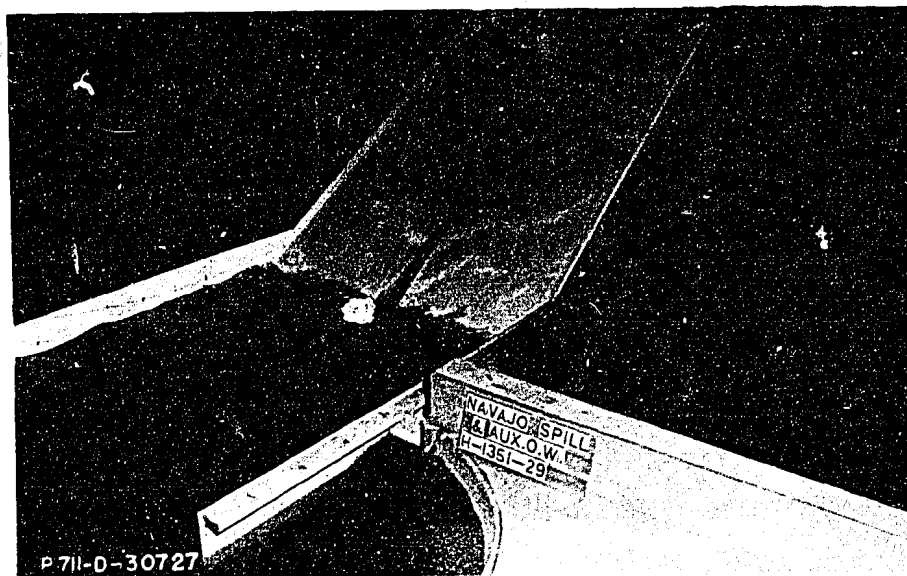
A. Spillway--2,000 cfs.  
Auxiliary O.W.--2,000 cfs.  
T.W. elevation 5711.

B. Spillway--3,400 cfs.  
Auxiliary O.W.--2,000 cfs.  
T.W. elevation 5711.

C. Same as in A.

NOTE: Recommended straight approach channel used with preliminary chute.

NAVAJO DAM SPILLWAY  
Roll Waves in Chute and Stilling Basin  
1:48 Scale Model

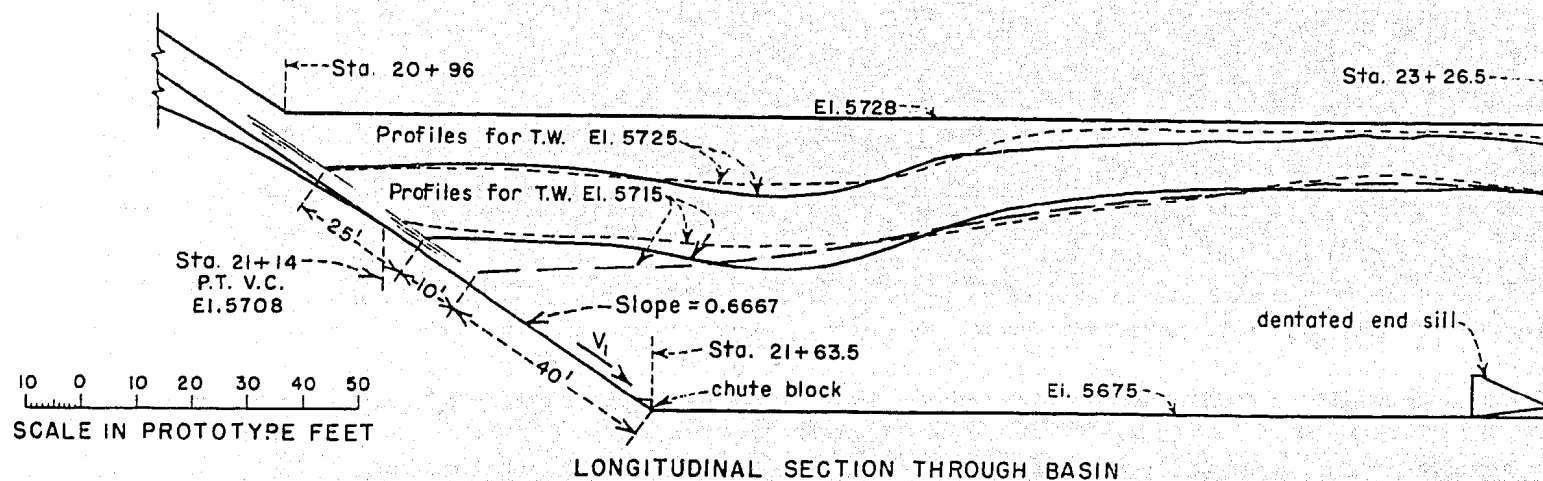
- PROFILE ALONG LEFT WALL FOR UNDISTORTED MODEL ( $V_1 = 110$  FEET PER SECOND)
- PROFILE ALONG RIGHT WALL FOR UNDISTORTED MODEL ( $V_1 = 110$  FEET PER SECOND)
- AVERAGE CENTER LINE PROFILE FOR DISTORTED MODEL ( $V_1 = 135$  FEET PER SECOND)

For tailwater elevation 5725 waves sometimes overtop left training wall from Sta. 22+24 to downstream end and right wall from Sta. 23+63.5 to downstream end. For tailwater elevation 5715 waves come to within four feet of top of walls.

NAVAJO DAM SPILLWAY  
 WATER SURFACE PROFILES IN RECOMMENDED STILLING BASIN  
 34,000 C.F.S.  
 1:48 SCALE MODEL

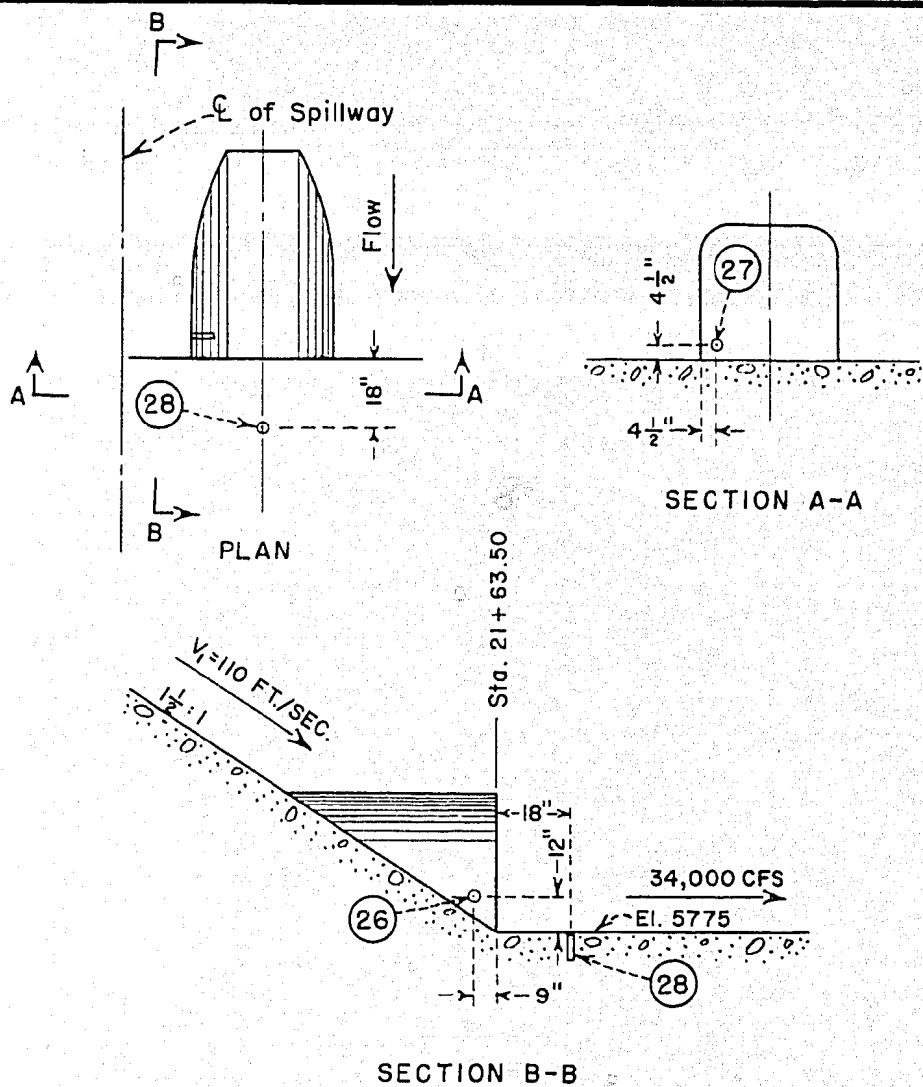
FIGURE 28  
REPORT HYD. 458

PIEZOMETER	PRESSURES IN FT. OF WATER	
	T.W. EL. 5711	T.W. EL. 5723
26	+32.6	+40.5
27	+14.3	+16.0
28	+34.0	+41.0

NAVAJO DAM SPILLWAY  
CHUTE BLOCK PRESSURES

1:48 SCALE MODEL

Pressures were measured on one of the chute blocks near the centerline of spillway and on the basin floor downstream from the block. At Piezometer 26 on the side of the block and Piezometer 28 on the floor downstream from the block, the pressures measured were about equal to the depth of flow for the design discharge (Figure 28). At Piezometer 27 on the downstream end of the chute block (where low pressures sometimes exist in other installations) the pressure was above atmospheric, but less than half of that measured at the other two piezometers. Lowering the tail water reduced the pressures and increased the effectiveness of the blocks. This was another indication that the basin was deeper than necessary for an entrance velocity of 110 feet per second.

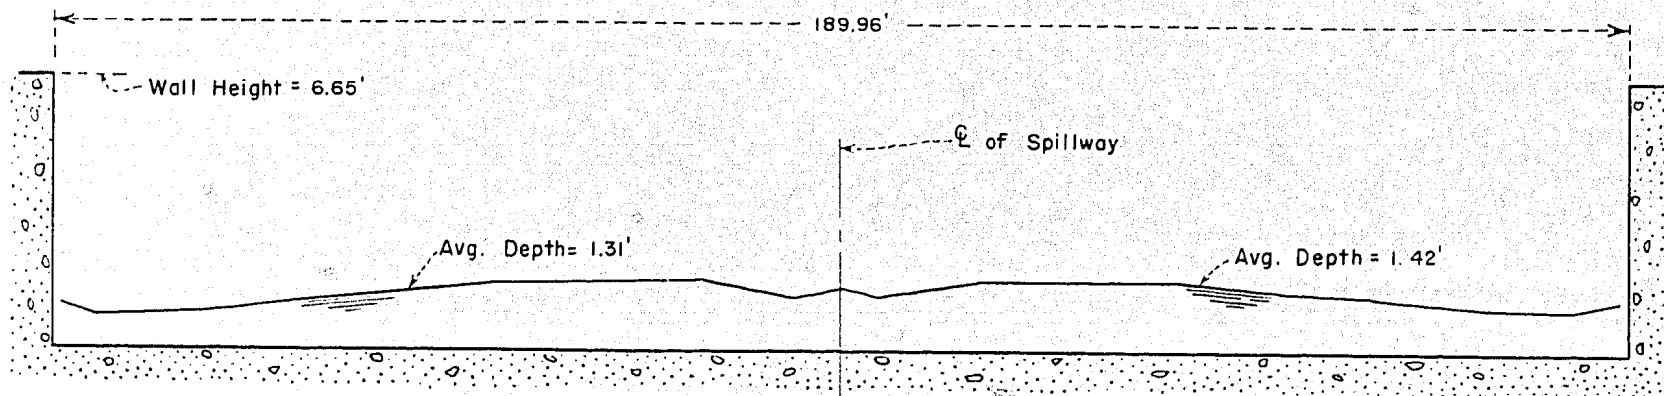
STATION 20+96

AVERAGE VELOCITY = 131.48 FEET PER SECOND

NAVAJO DAM SPILLWAY  
WATER SURFACE CROSS SECTION PROFILE -34,000 C.F.S.  
DISTORTED MODEL

1:48 SCALE MODEL

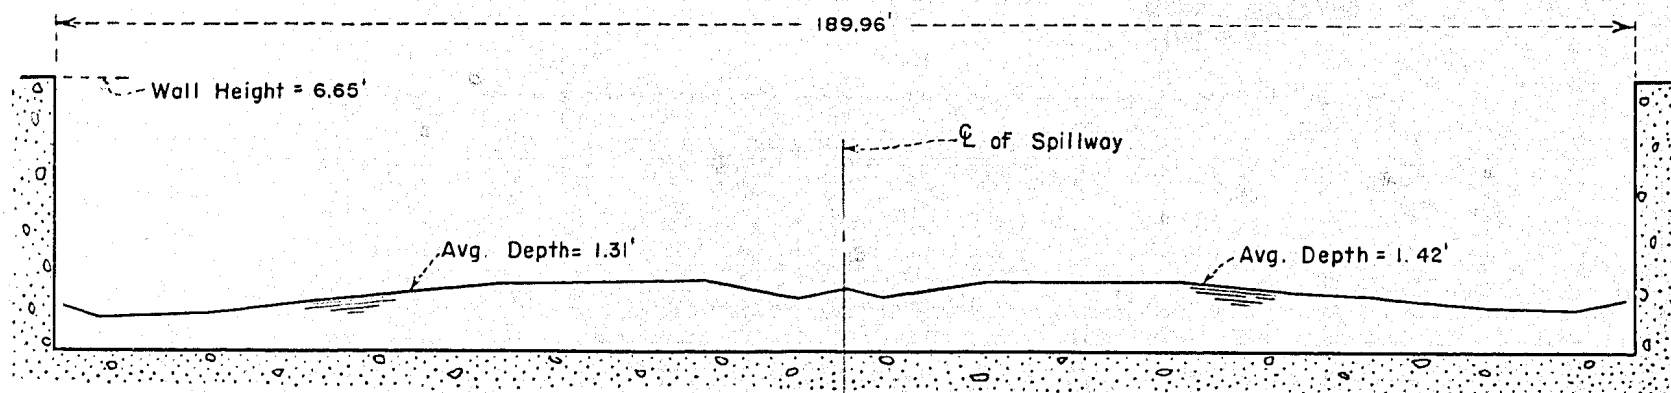
STATION 20+96

AVERAGE VELOCITY = 131.48 FEET PER SECOND

NAVAJO DAM SPILLWAY  
WATER SURFACE CROSS SECTION PROFILE -34,000 C.F.S.  
DISTORTED MODEL

1:48 SCALE MODEL

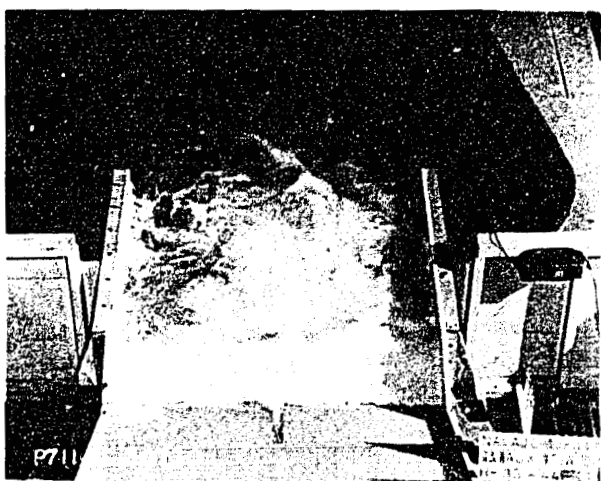
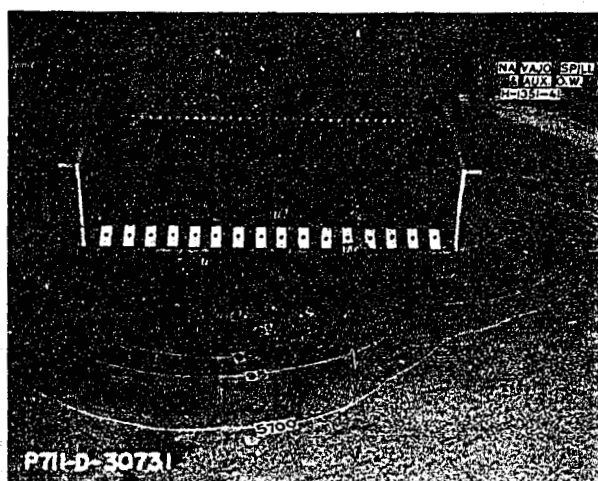
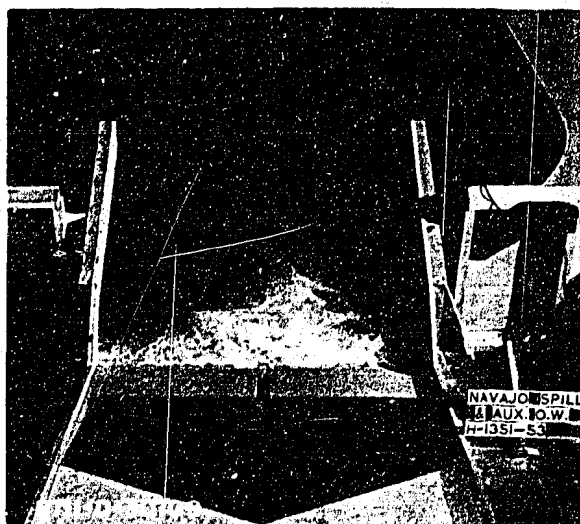
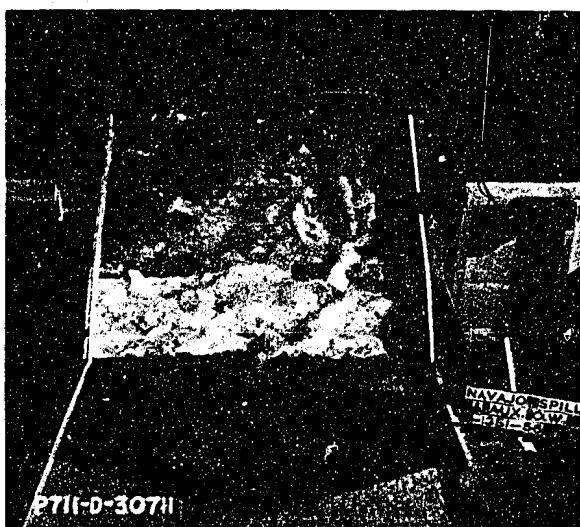
A. 8,500 cfs, T.W. elevation 5714.

B. 17,000 cfs, T.W. elevation 5716.5.

C. 34,000 cfs, T.W. elevation 5719.5.

D. Erosion after 1 hour operation of the model at 34,000 cfs.

Hump is 4 ft High by 176 ft Wide by 216 ft Long

NAVAJO DAM SPILLWAY  
Stilling Basin Performance for Distorted Model With Hump  
1:48 Scale Model

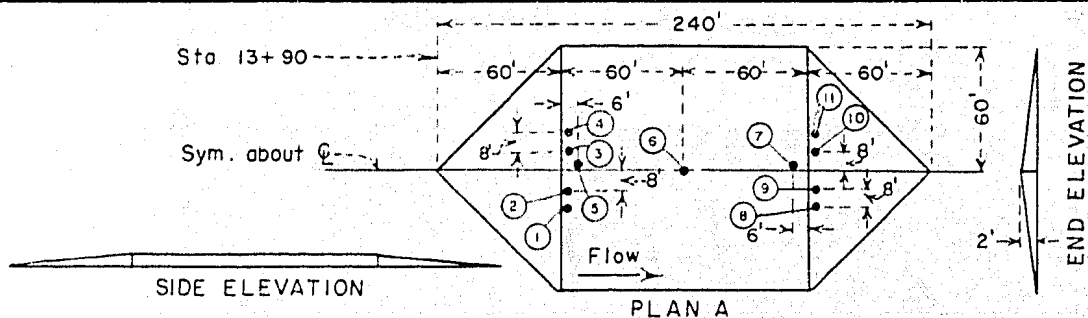
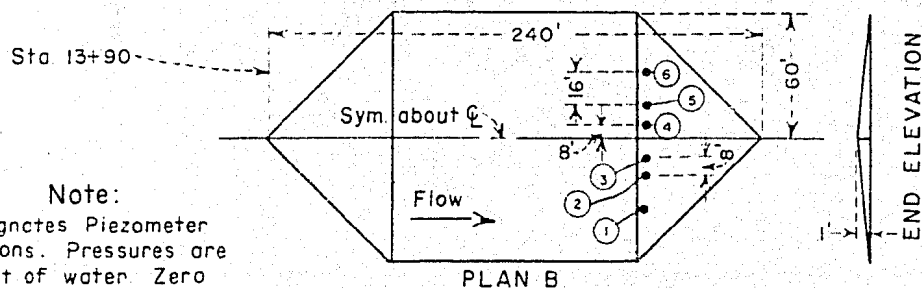
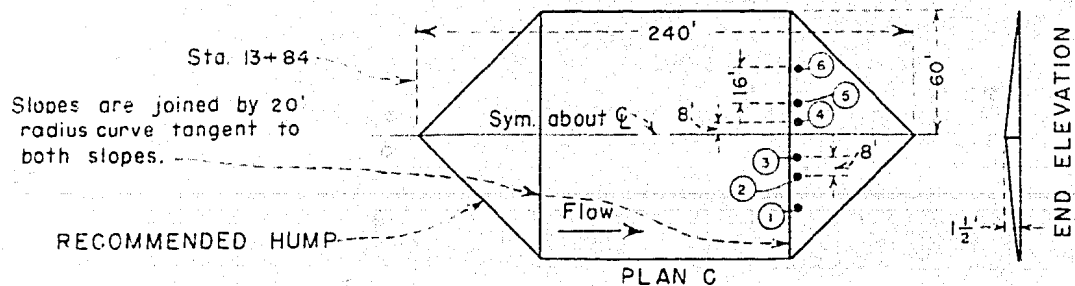
DISCHARGE CFS	PIEZOMETER PRESSURES										
	1	2	3	4	5	6	7	8	9	10	11
34,000	-5.8	-6.7	-4.8	-4.3	+2.9	+3.8	+4.3	-13.0	-8.6	-7.4	-7.7
17,000	-3.8	-5.3	-4.1	-2.9	+2.2	+2.5	+3.6	-8.6	-6.0	-5.5	-5.4

Note:  
① Designates Piezometer locations. Pressures are in feet of water. Zero pressure is atmospheric.

DISCHARGE CFS	PIEZOMETER PRESSURES					
	1	2	3	4	5	6
34,000	-2.0	-2.5	+3.5	+2.0	0.0	-3.0
17,000	1.0	-1.5	+2.0	+1.5	0.0	-2.5
8,500	-0.3	-1.0	+1.5	+1.3	-0.3	-1.5

DISCHARGE CFS	PIEZOMETER PRESSURES					
	1	2	3	4	5	6
34,000	-2.8	-0.3	+1.3	+3.5	+1.3	-1.5
17,000	-2.3	-0.3	+1.0	+2.5	+0.8	-1.5
8,500	-1.0	0.0	+0.8	+1.8	+0.8	-0.8

NAVAJO DAM SPILLWAY  
PRESSURES ON TESTED HUMPS  
1:48 SCALE MODEL

In the 1-foot-high hump, only the piezometers along the downstream slope change were installed, since this was found to be the area of greatest subatmospheric pressure. Again, the piezometers toward the outer edges showed the greatest subatmospheric pressure; however, the largest value was only 3 feet of water below atmospheric pressure and this occurred for 34,000 cubic feet per second. Since the 1-foot hump was not sufficiently effective in changing the course of the flow, a hump 1-1/2 feet high was installed with both the upstream and downstream slope changes joined by 20-foot-radius curves (Figure 8). The upstream end of the hump was placed at Station 13+84. The largest subatmospheric pressure measured on this hump was 2.8 feet of water at Piezometer 1 (Figure 33). Since this hump was quite effective in redistributing the flow at the toe of the jump for all discharges, it was recommended for the prototype. The recommended chute then is the preliminary chute with the addition of the recommended hump.

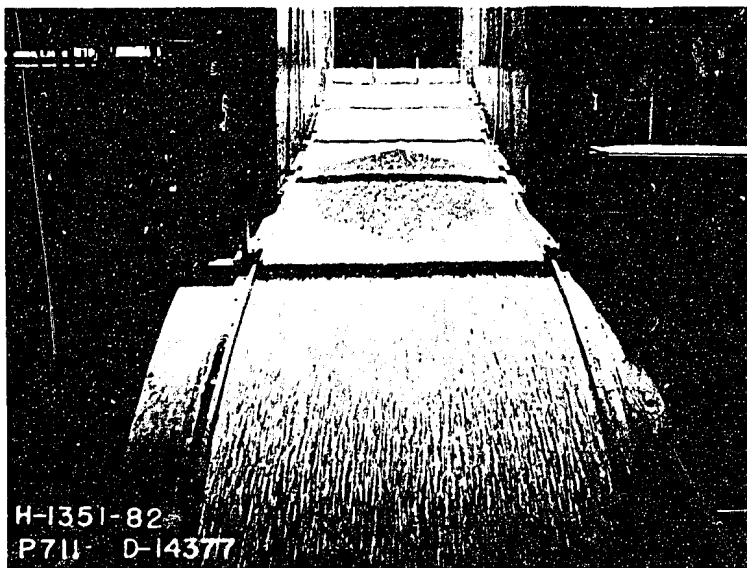
A. Hump 1-1/2 feet high by 120 feet wide by 240 feet long installed in undistorted model.

B. 34,000 cfs.

C. 34,000 cfs.

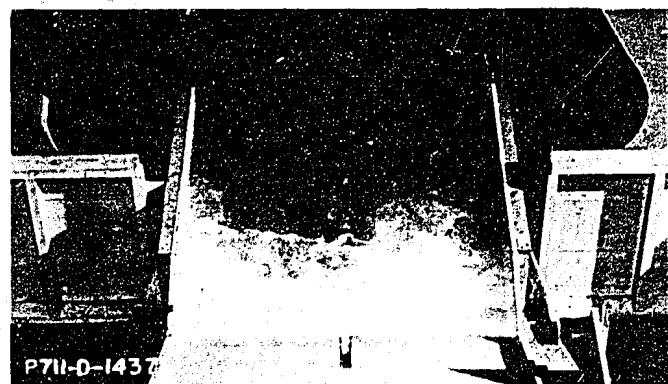
- A. Recommended hump  
1-1/2 ft high by 60 ft  
by 240 ft.

- B. 8,500 cfs  
T.W. elevation 5708.

- C. 17,000 cfs  
T.W. elevation 5716.

- D. 34,000 cfs  
T.W. elevation 5719.

NAVAJO DAM SPILLWAY  
Stilling Basin Performance--Recommended Chute and Basin  
1:48 Scale Model

Stilling Basin Performance--The basin performed very much as described for the preliminary basin tests since the basin itself had not been changed. However, the basin was utilized more effectively across its width because of the better lateral distribution of the entrance flow provided by the hump in the recommended chute (Figure 35). Chute block pressures were the same as shown in Figure 28 and water surface profiles were the same as shown in Figure 27.

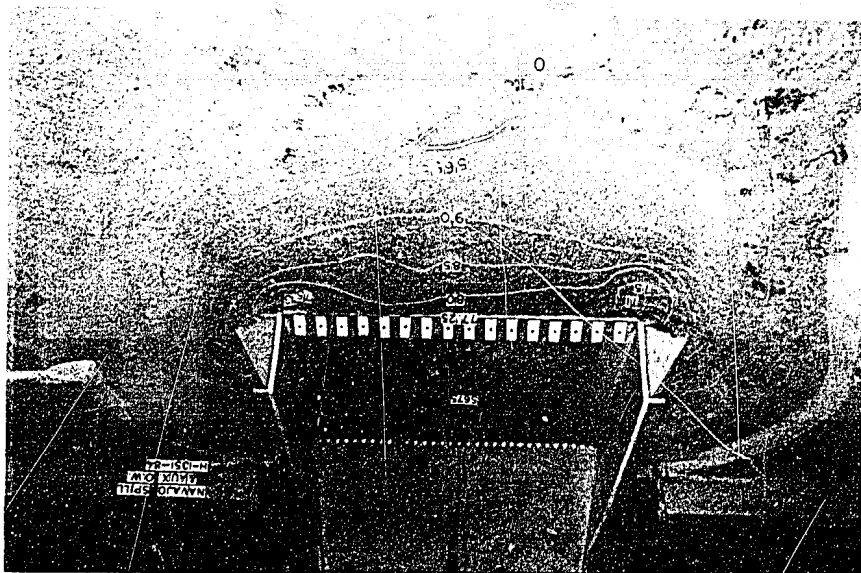
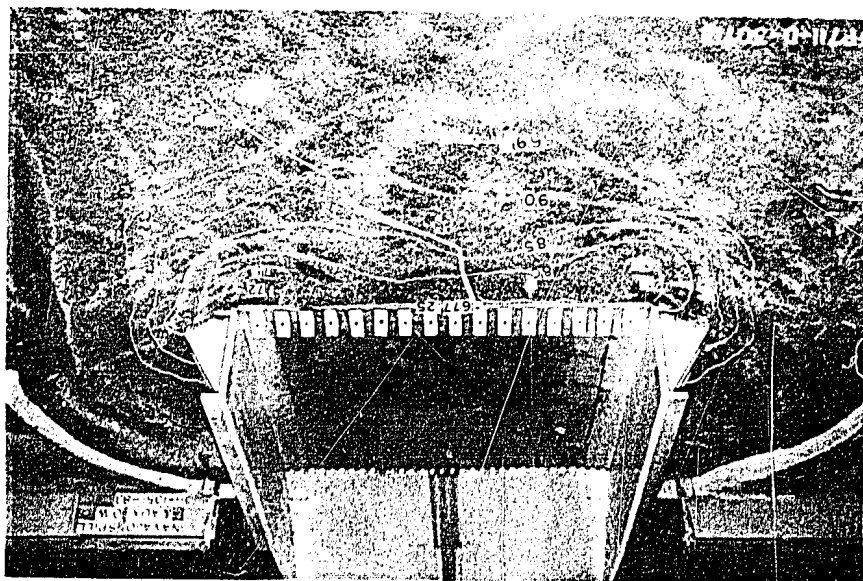
NOTE: Discharge 34,000 cfs; erosion test duration 1 hour  
 model time recommended spillway approach channel  
 and chute; counterforts on basin walls.  
 NAVAJO DAM SPILLWAY  
 Erosion Tests--Preliminary Basin Without Riprap  
 1:48 Scale Model

Erosion for tailwater elevation 5715.

Erosion for tailwater elevation 5723.
